Site Summary

The project area covers the stretch of Pickford Brook that runs between the culvert on Woodridge Avenue (SP 28985 80511) to the culvert at the eastern end of Parkhill Drive (SP 29235 80507) as show on the map above (approx. 250m). There is potential for work upstream of Woodridge Avenue, and this will be covered on the site visit for context, however the main priority is the stretch referenced here.

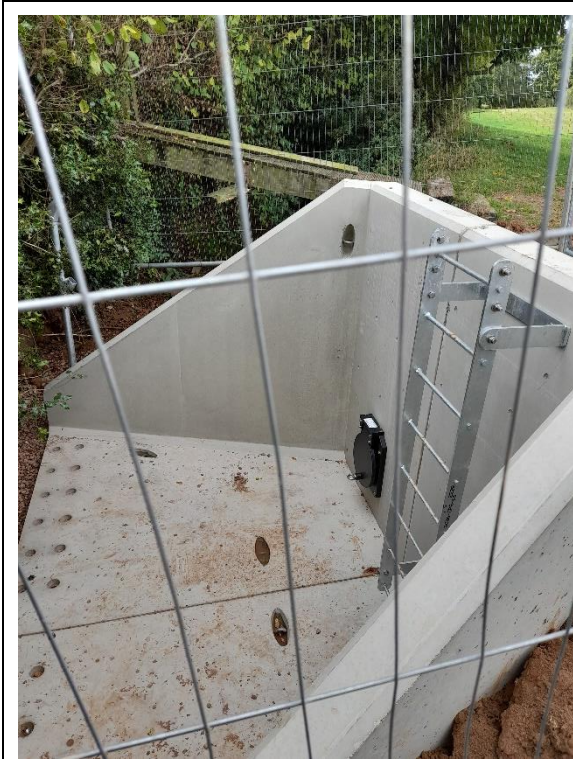
Issues upstream, including dominating headwall features running from SUDS ponds on new development site at Eastern Green and drying up of stream over summer. Taken at SP 28390 80568.

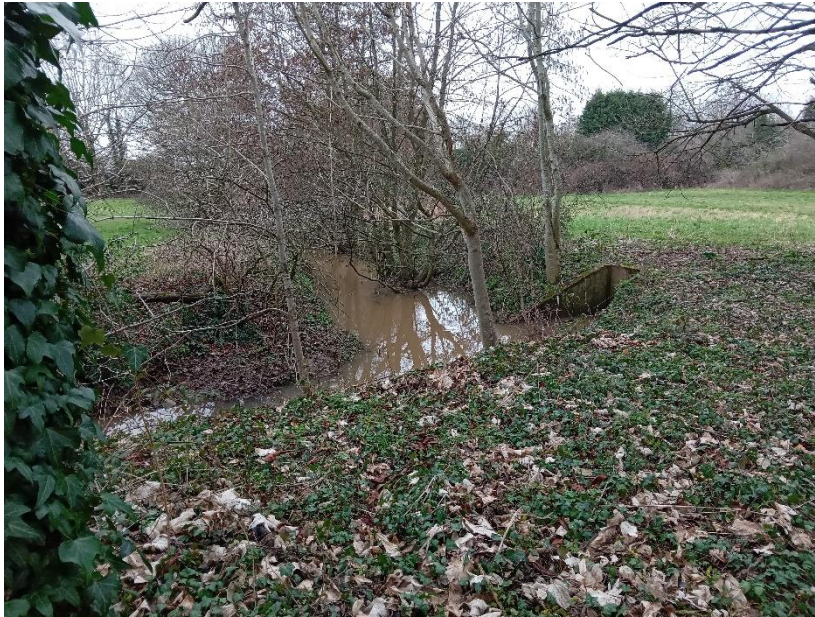
Example of outfall at SP 28926 80526 (have previously talked with the local authority about an online pond or attenuation feature here)

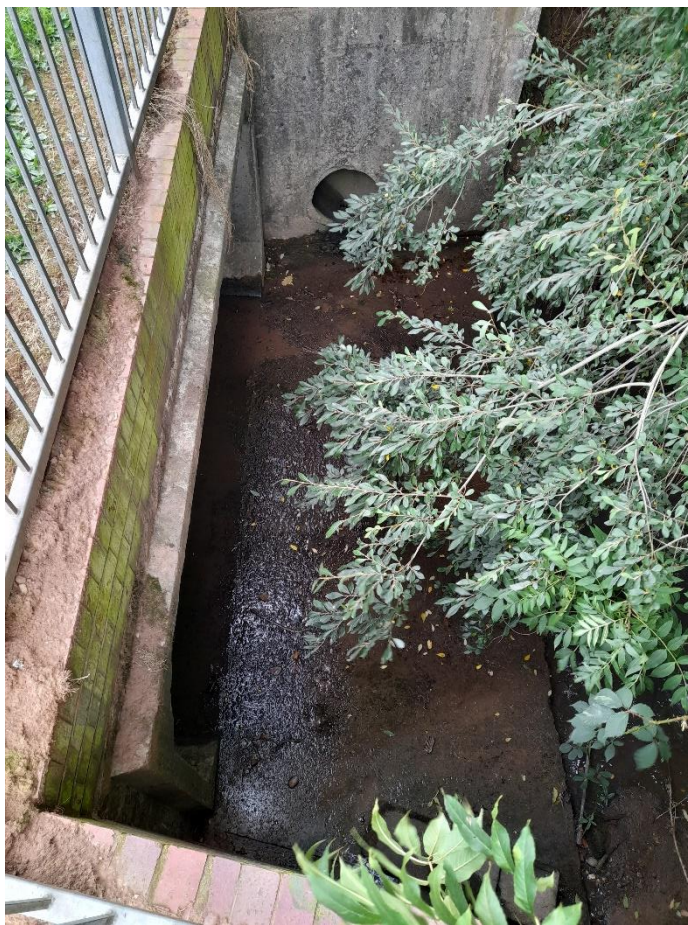
Start of priority area: culvert at SP 28985 80511. We're unable to do anything about the culvert but can improve morphology downstream of here.

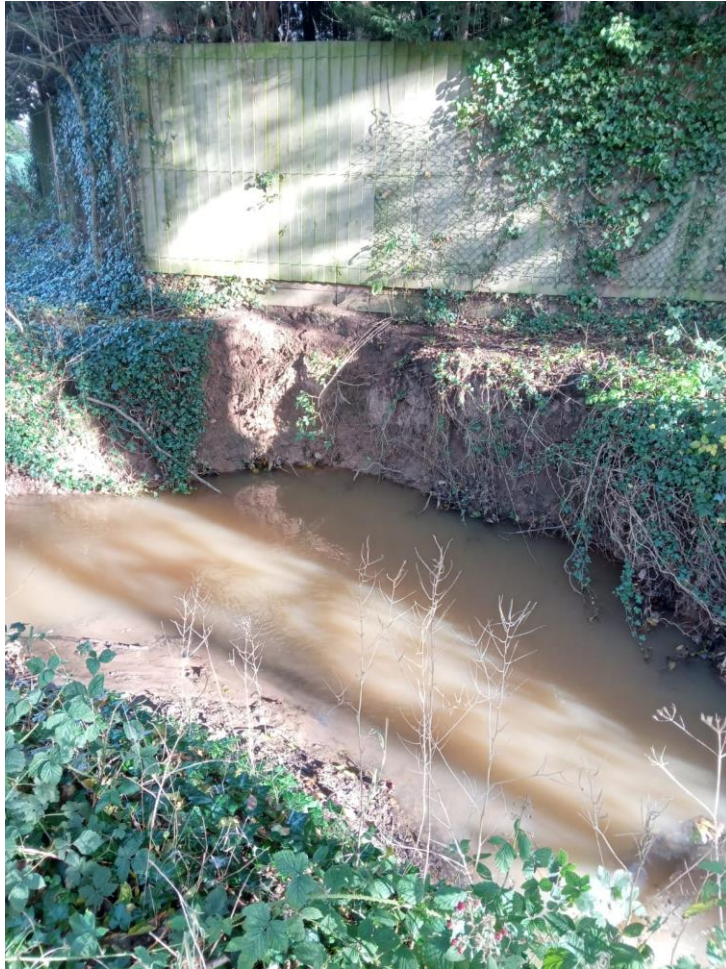
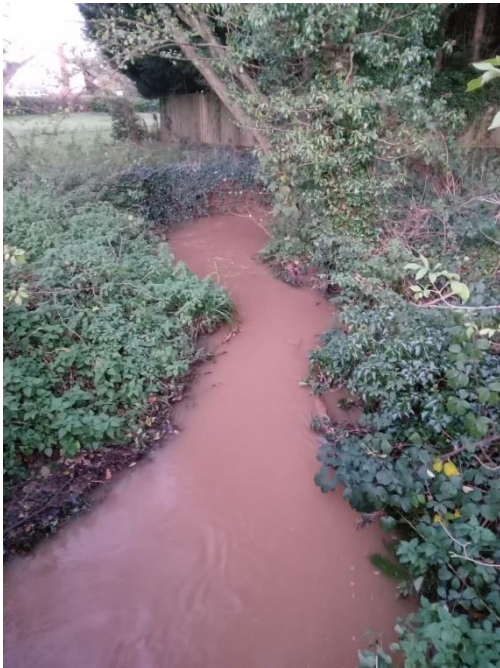
Fencing being undermined just downstream of bridge and same area in spate last winter

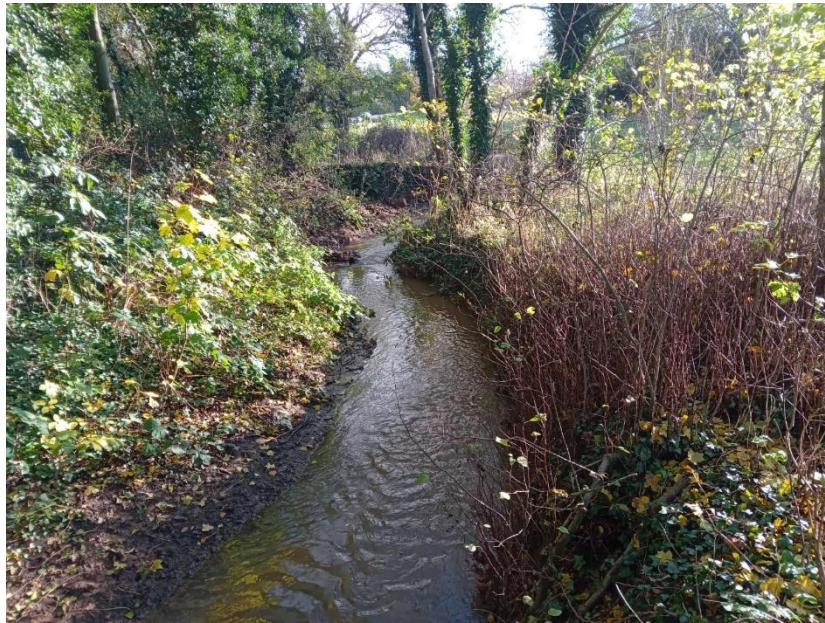
Some nice stretches of gravels (that have been revealed increasingly over the last few months with improvements in sediment issues upstream), showing potential of the whole stretch

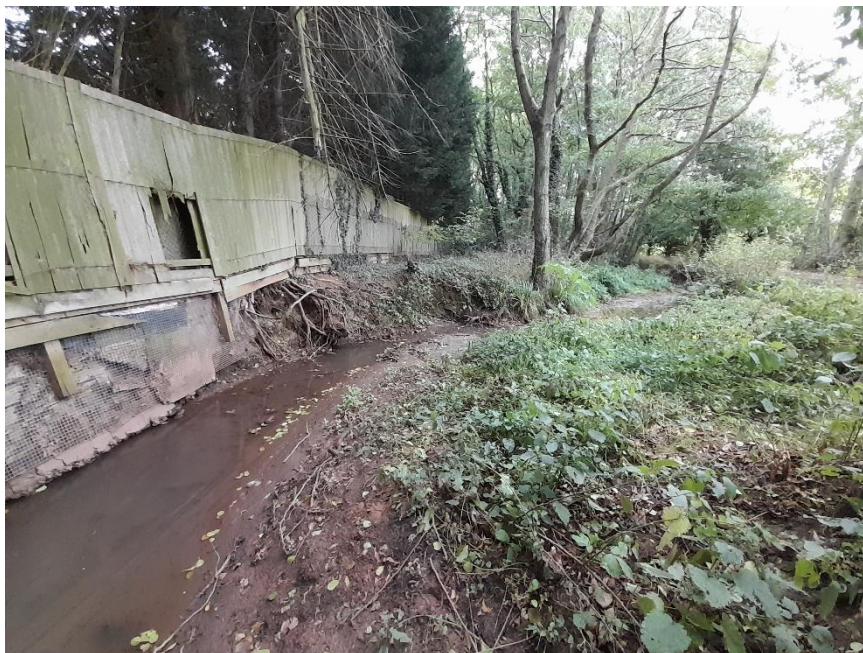
Fencing being undermined (natural solution needed) and potential area on the right for a berm feature

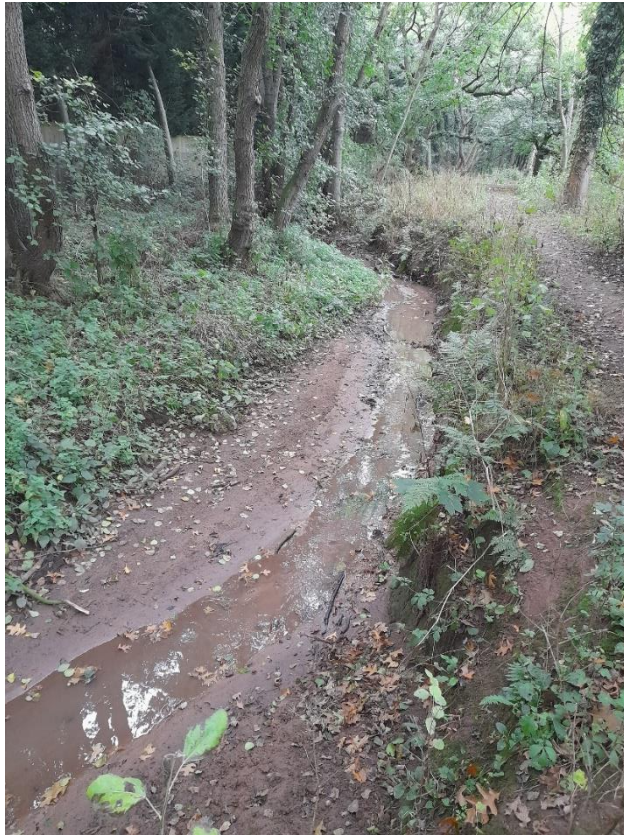
Build up of sand on banks and in-stream

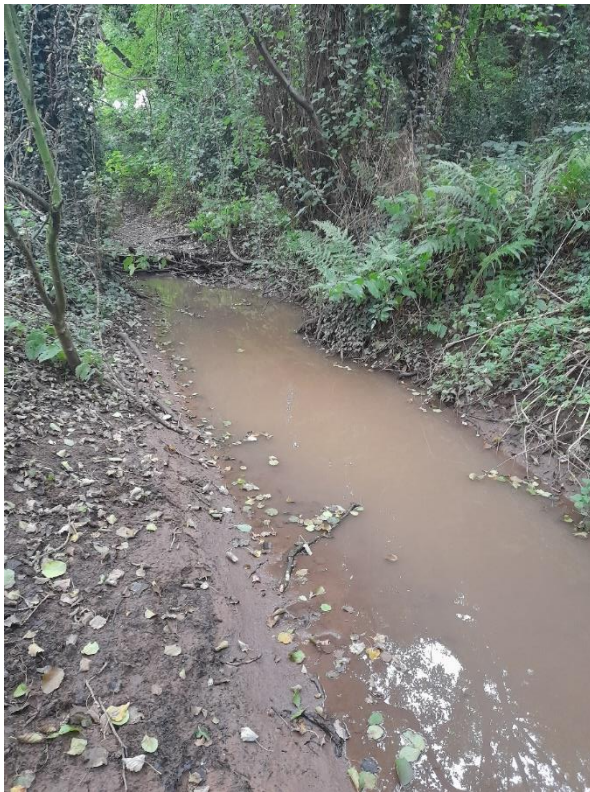
Sluggish and uniform stretches

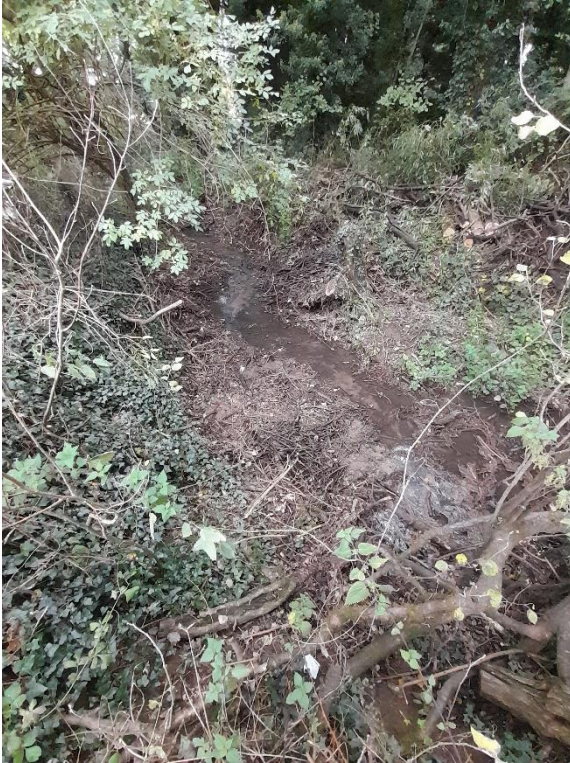
A lot of woody material and log jams, creating some nice features in places

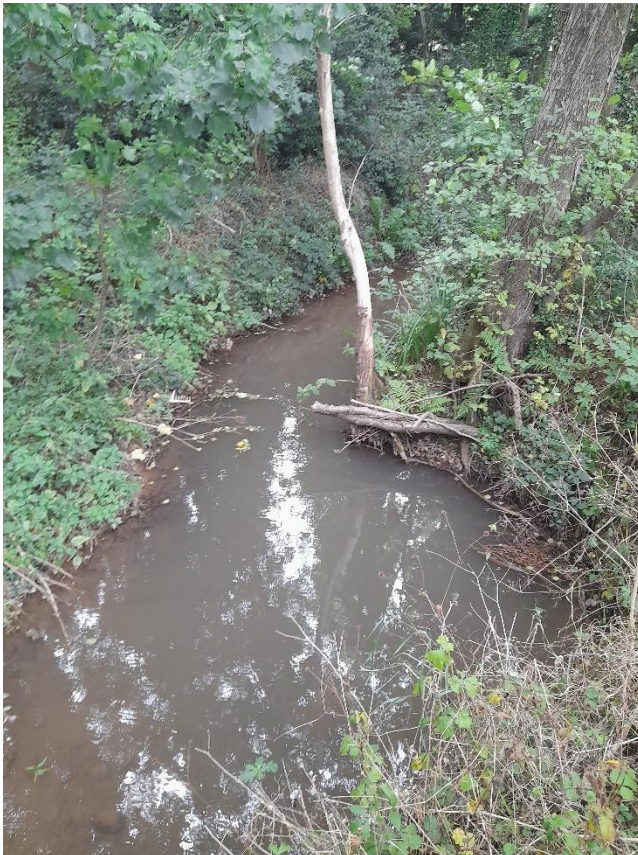
Some deeper pools

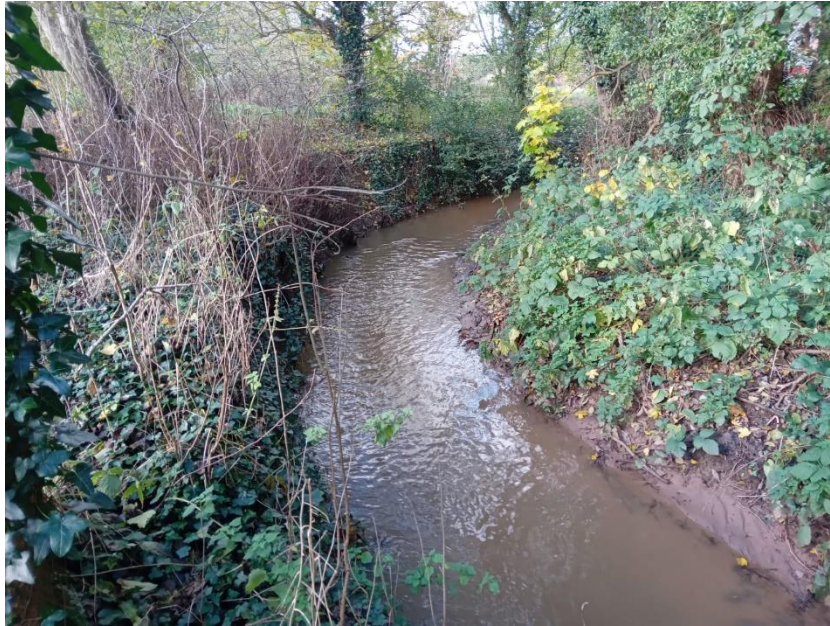
Over-widened,
uniform sections
